**OFFICE OF THE SPECIAL INSPECTOR GENERAL  
FOR AFGHANISTAN RECONSTRUCTION**

**INSPECTION OF IMPROVEMENTS TO THE  
KHOWST CITY ELECTRICAL POWER SYSTEM:  
SAFETY AND SUSTAINABILITY ISSUES  
WERE NOT ADEQUATELY ADDRESSED**

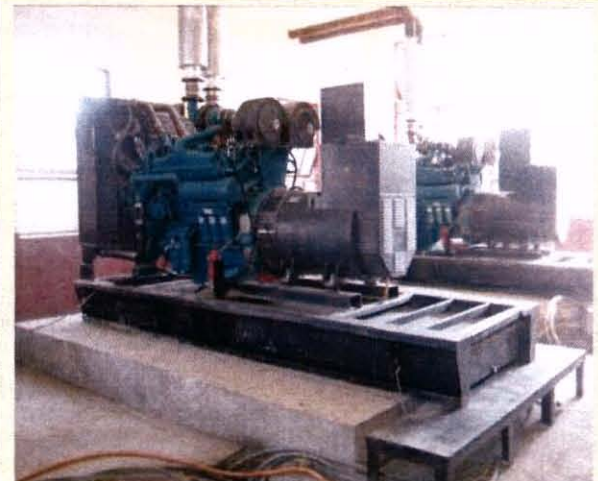
Photo: One of the three new generators installed at the Khowst City Power Plant 1 using CERP funds through a project initiated and overseen by the Khowst PRT: (Photo—SIGAR)

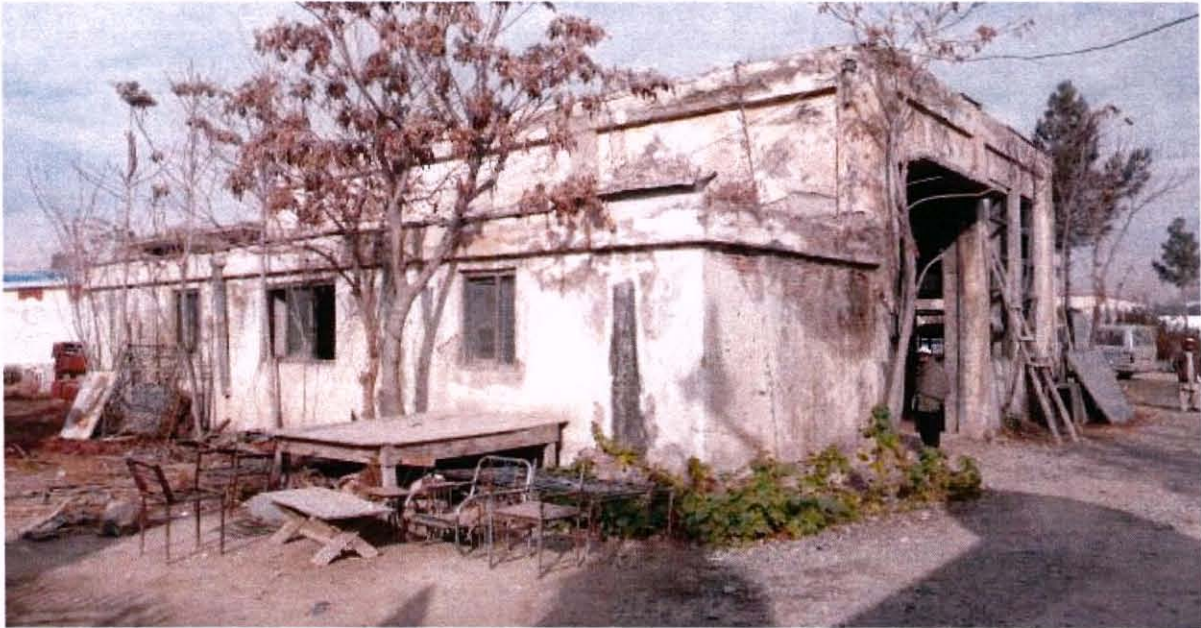
**Photo 1: Power Plant 1 PRE-IMPROVEMENT Condition of Power Plant 1, Spring, 2008 (Courtesy of Khowst PRT)**

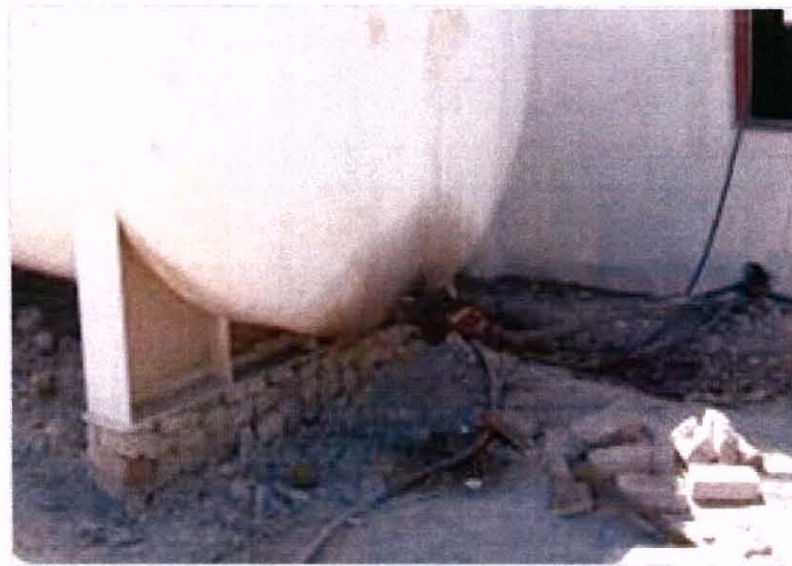
**Photo 4: Power Plant 1 PRE-IMPROVEMENT**—The 20,000 liter diesel fuel storage tank located at the outside rear wall of the main Power Plant 1 building. The tank is balanced on a platform of loose bricks with no spillage containment. Hoses are leaking fuel into the ground. The support deficiencies and lack of a spill containment area were documented requirements for the project in January 2008; however, no provision to improve this condition was made in the final scopes of work for the project. This photo documents the conditions observed by the SIGAR Inspection Team in May 2009. (Photo courtesy of Khowst PRT)

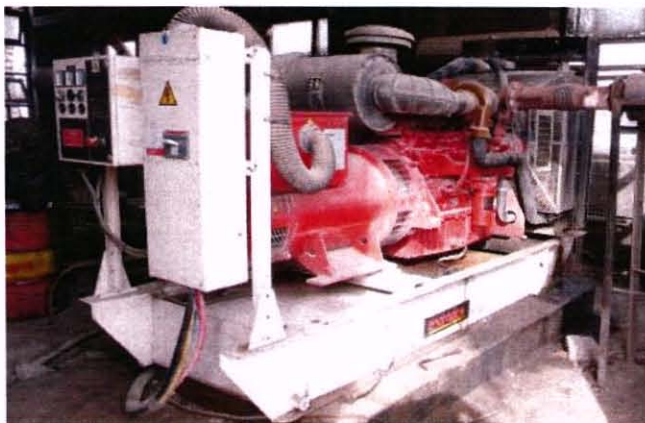
**Photo 5: One of the two 400kW generators installed by UNDP in 2003 that were operating prior to the rehabilitation of Power Plant No. 1 in 2008. Both generators are still in operation; at Power Plant 1 as the main backup power source, and the other generator relocated to serve as the only power generation source for Power Plant 2. (Courtesy of Khowst PRT)**

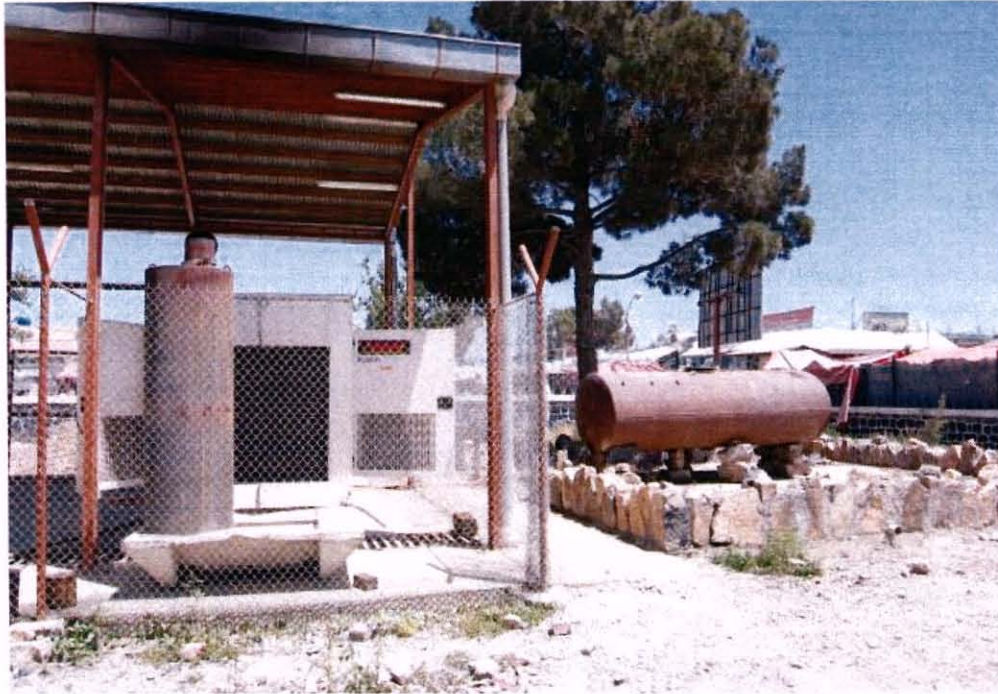
**Photo 6: Power Plant 2. A view of the one of the 400kW generators relocated to an outdoor enclosure in the southern part of Khowst City at Power Plant 2. To the right is improvised diesel fuel storage tank, balanced on rocks and encircled by a containment area made up of large rocks cemented into place. Further the chain link fence surrounding the outdoor enclosure does not reach the roof and would not provide a barrier to anyone attempting to access the enclosure without permission. May 2009. (Photo—SIGAR)**

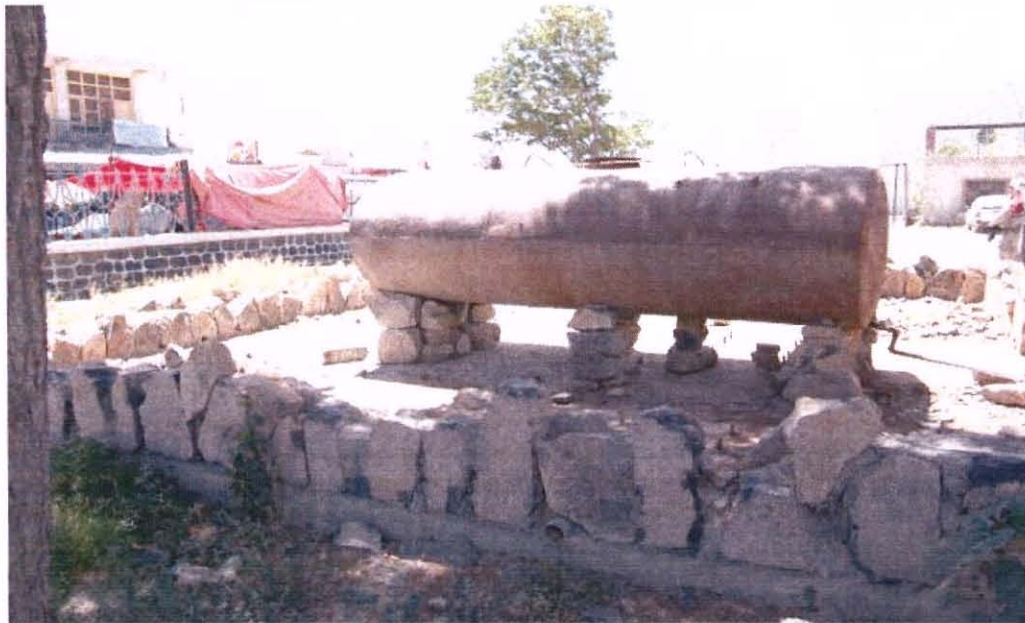
**Photo 7: Power Plant 2. Corroded fuel tank used as a diesel fuel reservoir. The tank is supported by loose rocks and the spill containment wall is inadequate (Photo—SIGAR)**

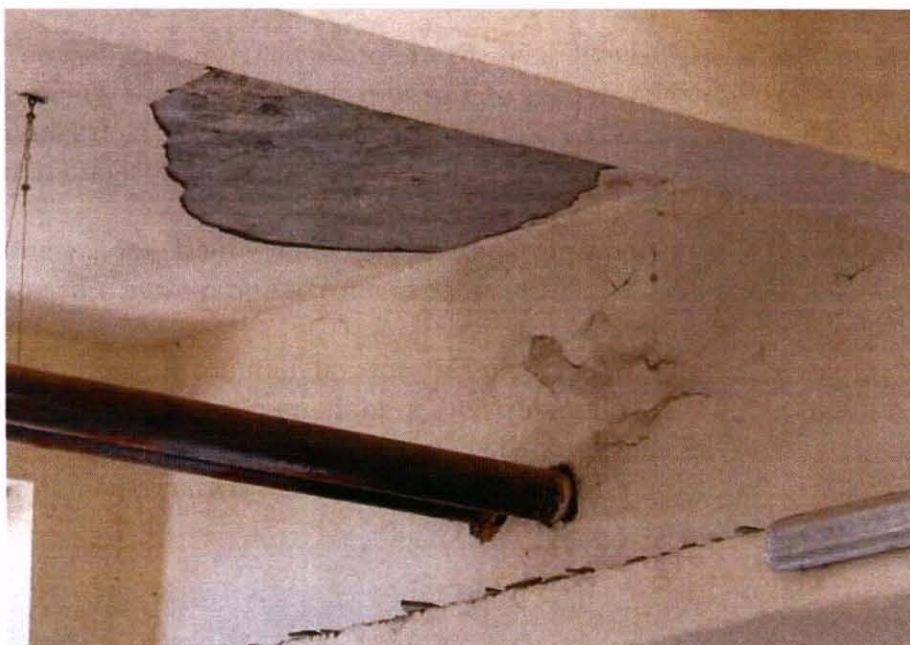
**Photo 8: Power Plant 1. A view of the ceiling area in the rear left corner of Power Plant 1 that shows extensive cracking and deterioration of the plaster work less than 1 year after the building was renovated. (Photo—SIGAR)**

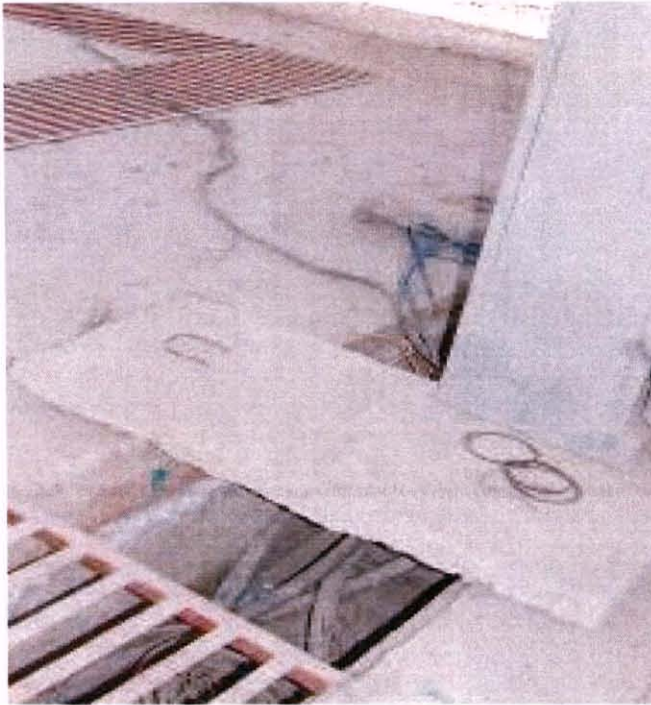
Photo 9: Power Plant 2 - View of the power distribution panel being balanced on one of two concrete slabs without any other means of support. (Photo—SIGAR)

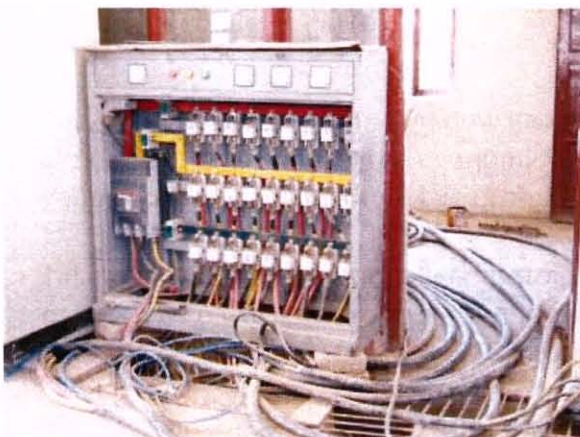
**Photo 12: 400 kW distribution panel at Khowst Power Plant 1 with high voltage cables lying exposed. Additionally the distribution panel is propped up with loose bricks. (Photo taken by SIGAR)**
